Keeping \$2,400,000 out of the Landfill

Aerial Infrared Process Images

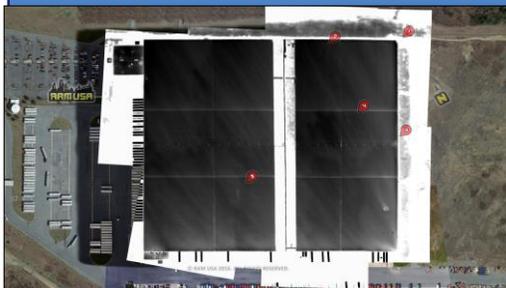
Moisture is detected

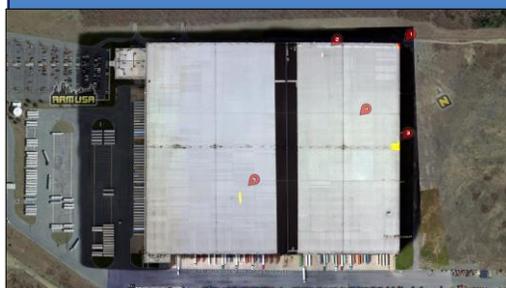
Thermal anomalies are pinpointed
